TECHNICAL BULLETIN C-940

August 12, 1966

USM RESEARCH _ _ _ COLUMN FIREPROOFING
RAIN EXPOSURE AND WEATHERING TEST

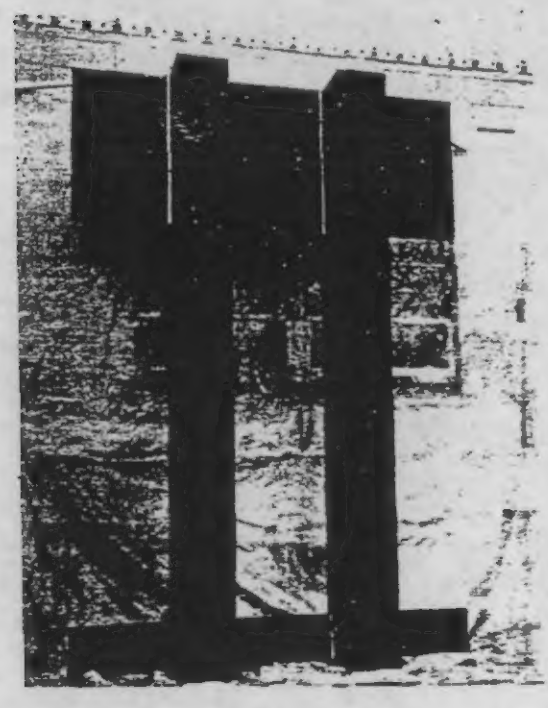
A full scale mock-up consisting of two columns a full story high (12 feet) connected by means of a spandrel plate was constructed of wood and covered with hardboard. The mock-up was constructed such that the ground level would be at the same level as the floor level in the actual building; see Figure 1.

Fig. 1 - Assembly prior to spraying

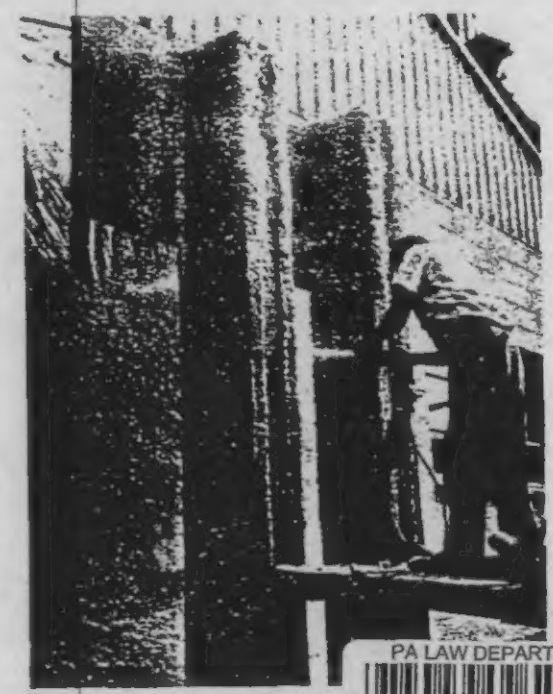
The entire assembly was placed outdoors and sprayed with 1" of BLAZE-SHIELD Type D fiber on July 13, 1965; see Figures 2 and 3. Some 16 hours after completion of spraying the assembly was exposed to the erosive effect of impinging water jets, one directed at each column; see Figure 4. The flow from each jet was approximately 3 gallons per minute.

Fig. 2 - Application of BLAZE-SHIELD Type D sprayed fiber C-313

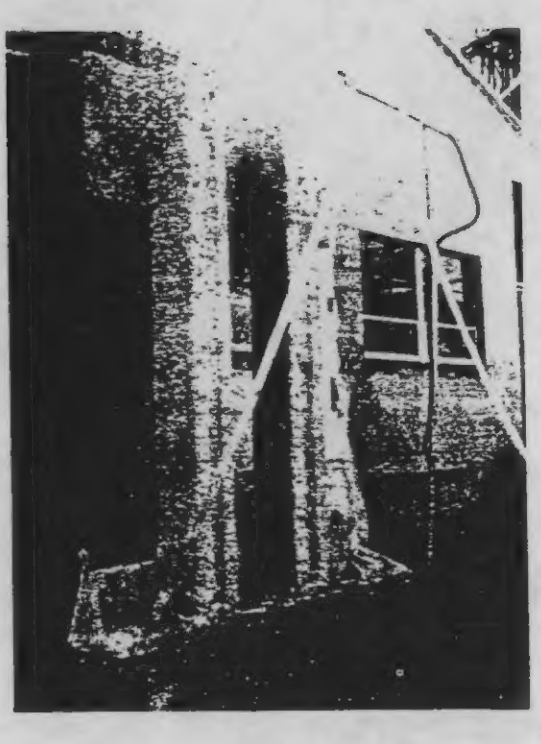
The water jets were kept on for 6 full hours. This amounted to approximately 21 inches of water falling on the assembly, which is much in excess of any rainstorm one would normally experience. This rainfall is greater than a six month rainfall in this area.

Figure 4
Impinging water jets directed at columns

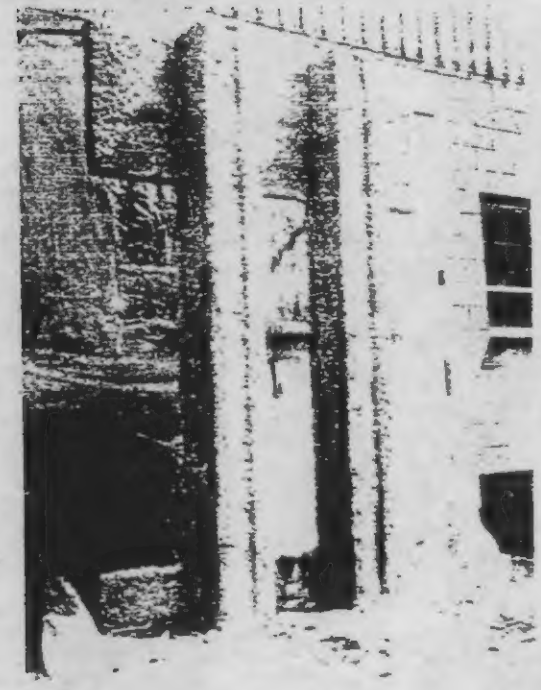
The water jets were turned off after 6 hours of exposure and photographs of the assembly were taken. The only place any fiber had come loose from the assembly was on the top portion of the lower spandrel plate; see Figures 5 and 6. This is a direct result of the water collecting on the lower edge of the upper spandrel plate and falling down 8 feet onto the lower spandrel top edge.

Figure 5
View after 6 hour water exposure
(picture taken from left side)

Figure 6
View after 6 hour water exposure
(picture taken from right side)

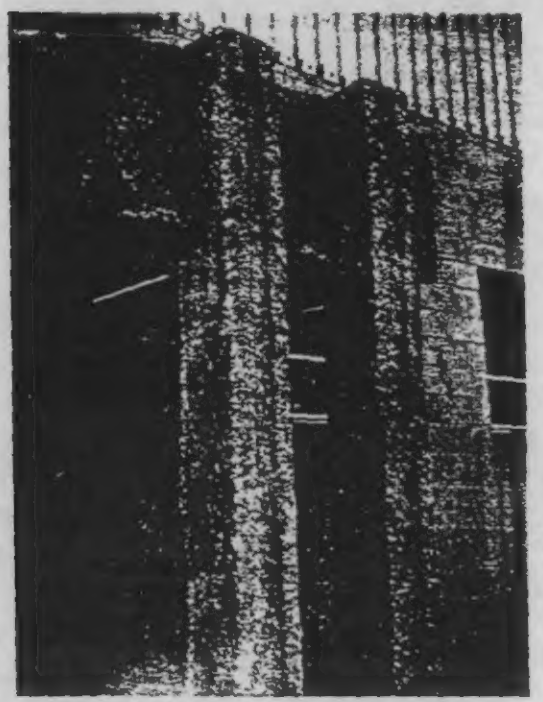
On July 13, 1966, exactly one year later, the assembly was inspected and photographs taken. During the winter approximately 48 inches of snow had fallen, while from January 1, 1966-18 inches of rain had accumulated. The fiber is in excellent condition, is firm to the touch and has not worn down under the year's exposure to the weather; see Figures 7 and 8.

Figure 7
Assembly looking right
